***Environmental Baseline Survey at
North Truro Air Force Station,
Truro, Massachusetts***

***Final
November 1994***

Radian Corporation
155 Corporate Woods, Suite 100
Rochester, New York 14623

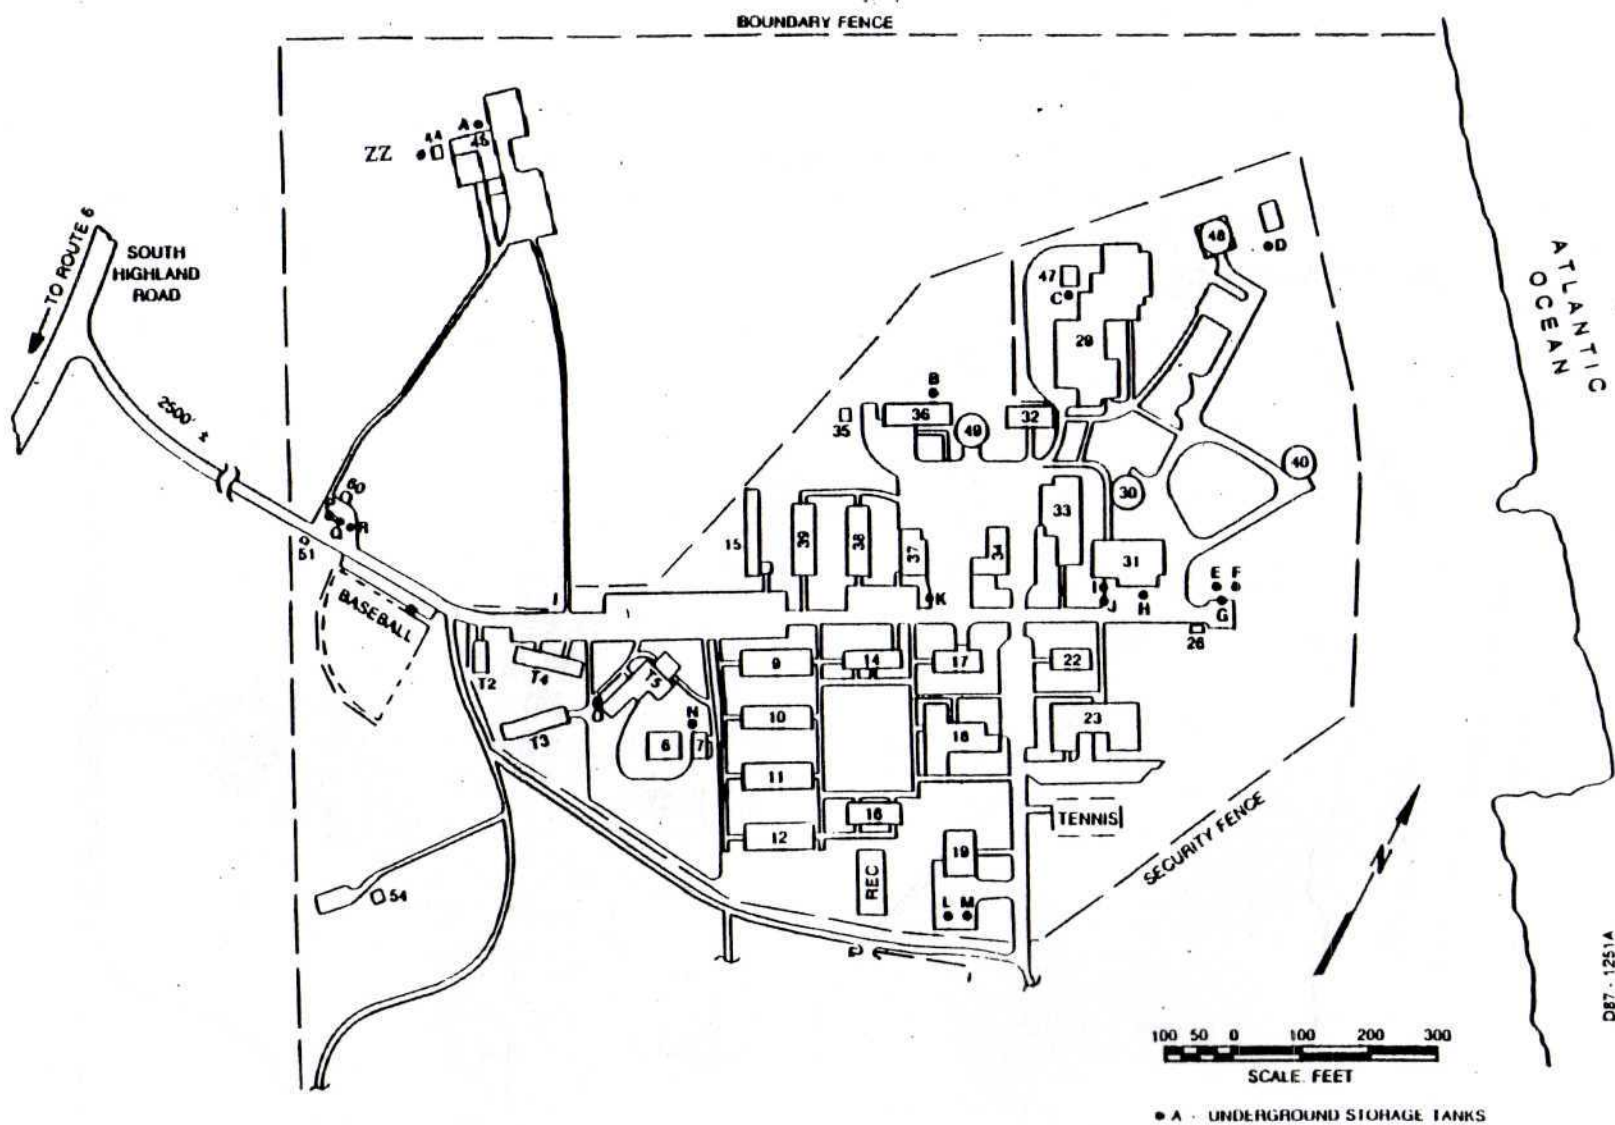
Figure 3-2. Location of Underground Storage Tanks, Support Area

There were a total of 49 underground storage tanks (USTs) at the Station; 19 in the Support Area, 29 in the Housing Area, and 1 at the GATR site (listed in Table 3-2 and shown in Figures 3-2 through 3-4). During the period of operation, tanks contained various grades of fuels (diesel, gasoline, furnace oil, etc.) and waste oils. All tanks were asphalt-coated carbon steel. No secondary containment or overfill protection was provided for the tanks since, at the time of installation, these technologies were not commonly used or required.

At Tank C, Total Petroleum Hydrocarbon (TPH) concentrations up to 400 ppm and volatile organic compound (VOC) concentrations up to 20 ppm were detected in the soil surrounding the tank. The surrounding soil was excavated to a depth of approximately 10 feet. The proximity of the adjacent buildings prevented further excavation. A soil boring completed at the site during March 1991 confirmed the original findings: petroleum hydrocarbons were present in the soils to a depth of approximately 30 feet below ground level (BGL), but were not present in the 35- or 40-foot BGL samples. The document entitled "Limited Site Investigation Report," (16) concluded that there was little chance of

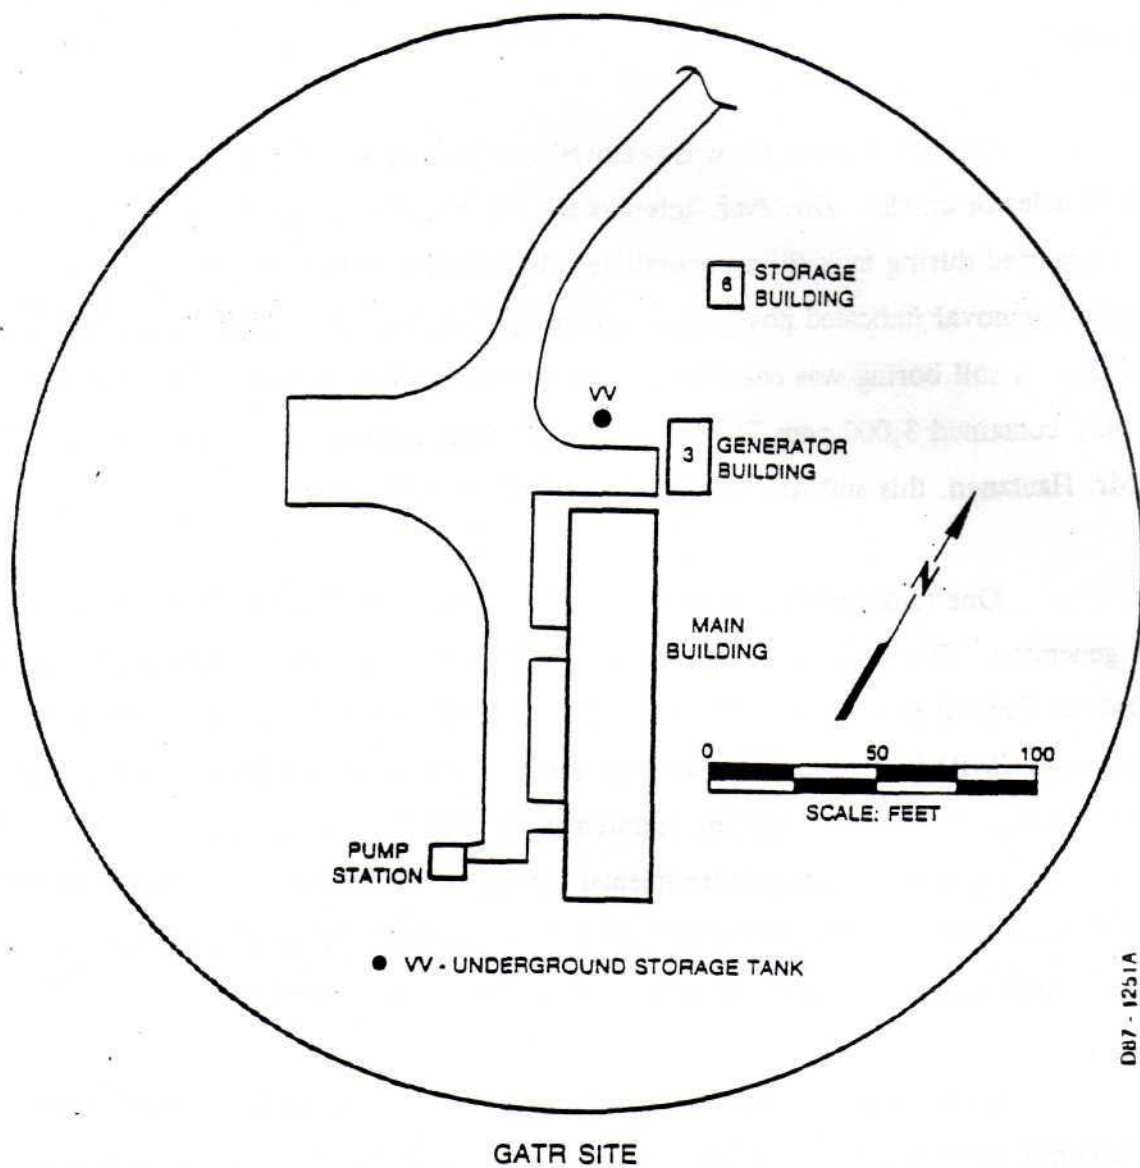
Figure 3-4. Location of Underground Storage Tanks, GATR Site

Tank VV (Area G) was removed and found to be in good condition, with no signs of holes or cracks. However, this was the site of a documented spill of No. 2 fuel oil which occurred during tank filling operations. Initial screening of the site by Dennison during the removal indicated possible petroleum hydrocarbon contamination to a depth of 22-feet BGL. A soil boring was completed at the site during March 1991. The sample from 5 feet BGL contained 3,000 ppm TPH; however, no other sample contained measurable TPH. Per Mr. Hautanen, this soil was excavated and replaced with clean fill.

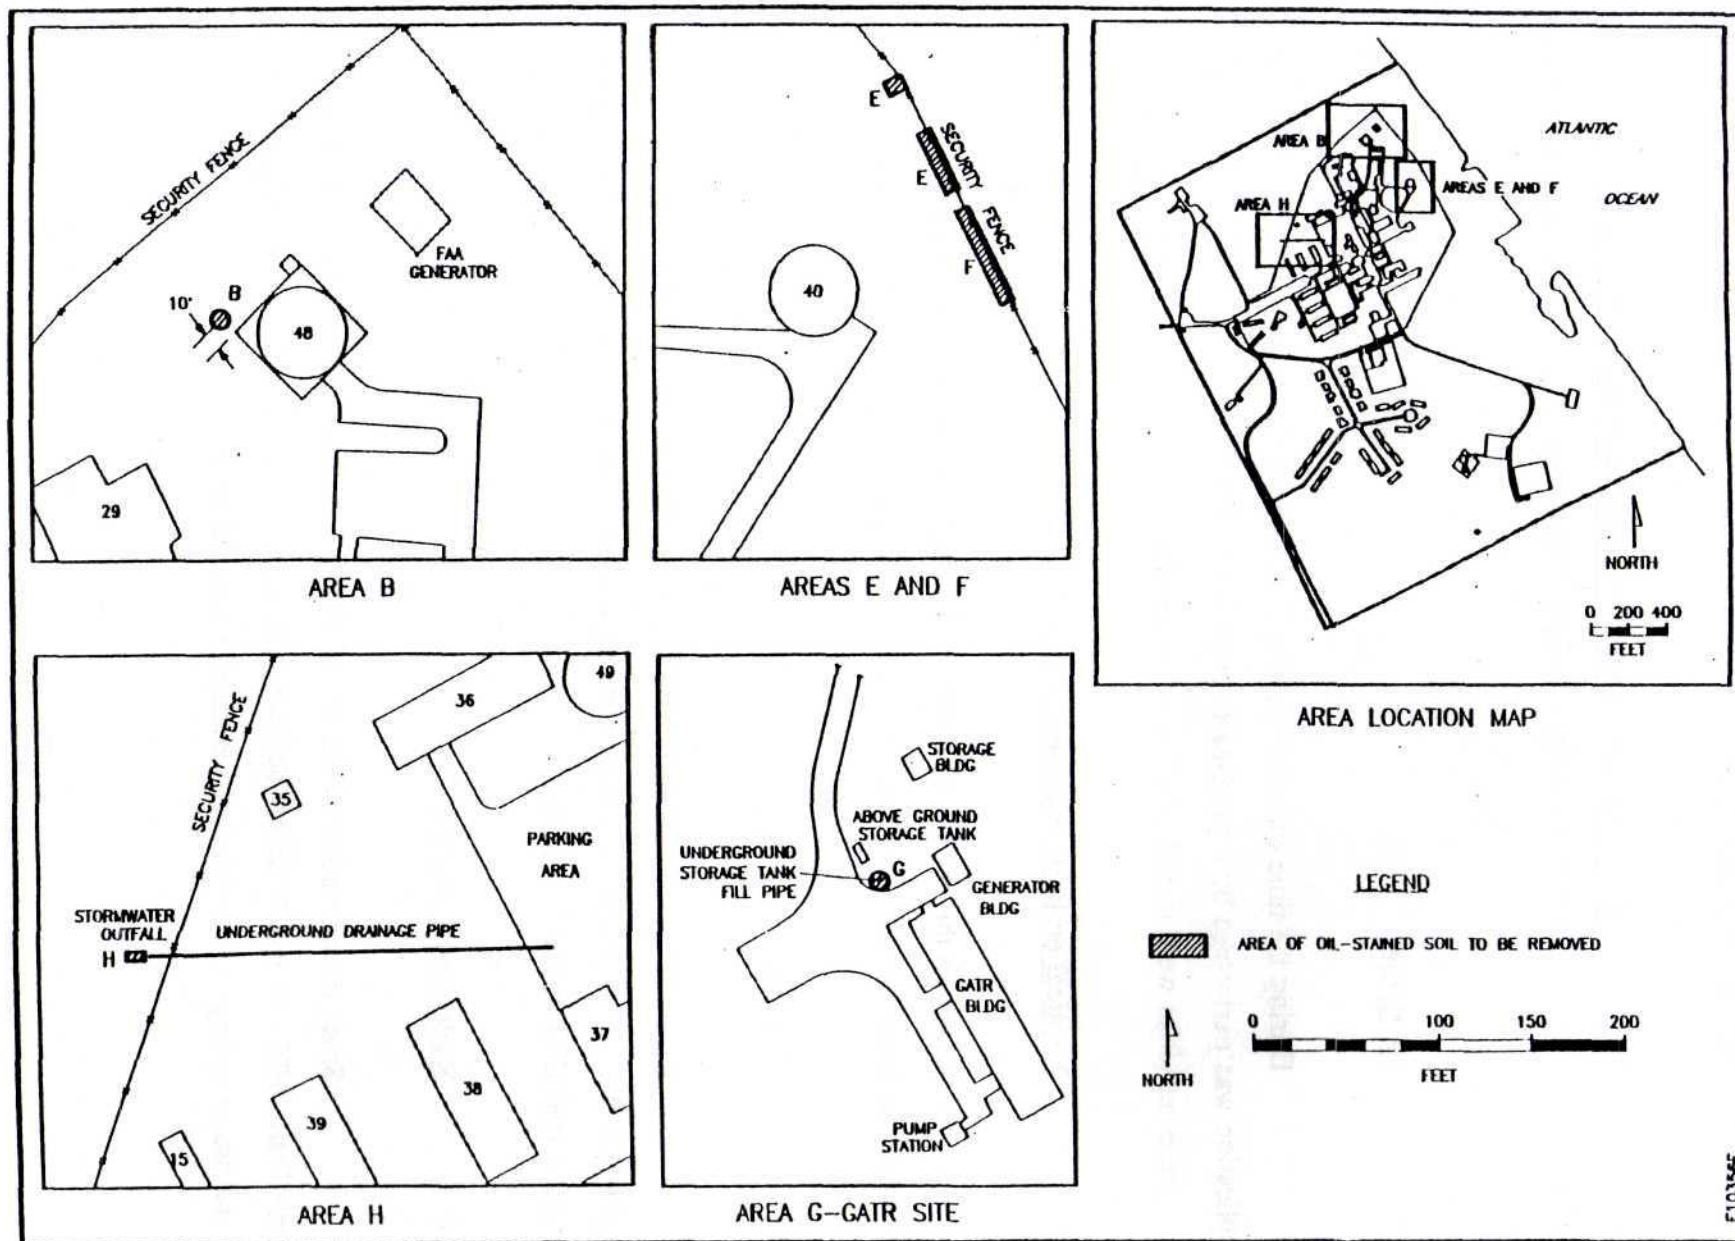
Figure 3-5. Location of Oil-Stained Soils

During the August 1987 site visit, several areas were identified with oil-stained soil. These areas, and the remedial actions taken, are described in Table 3-3, and shown in Figure 3-5. Following the remedial activities described in the Table, the Massachusetts Department of Environmental Protection (DEP) requested the following additional activities related to soil contamination:

Area	Location	Dimensions	Depth (ft)	Max TPH Results (ppm)	Max PCB Results (ppm)	Comments
B	Near Building 48 (North side of building)	10 ft. dia. circle	6	8,200	0.40	Area may have been used to drain oils containing PCBs. Site cleanup performed in June 1990 by Dennison Environmental.
E (N portion) (E1)	East of Building 40 (former radar tower), near perimeter fence	5 ft. square	2	15,000	Not detected	Stained with oils of unknown origin. Site cleanup performed in June 1990 by Dennison.
E (S portion) (E2)	East of Building 40 (former radar tower), near perimeter fence	5 x 15 feet	2	--	--	Stained with oils of unknown origin. Site cleanup performed in June 1990 by Dennison.
F	East of Building 40 (former radar tower), near perimeter fence	5 x 70 feet	2	10,000	Not detected	Stained with oils of unknown origin. Site cleanup performed in June 1990 by Dennison.
H	West of Building 37 (Motor Pool), near stormwater outfall	5 x 10 feet	2	1,800	3.51	Stained with motor oil spilled during routine vehicle maintenance. Cleanup completed by Dennison in October 1990.

G	GATR Site	5 ft. dia. circle	5	3,000	--	Site of a documented spill of No. 2 fuel oil which occurred during tank filling operations. Per Mr. Hautanen, excavated and replaced with clean fill

- Approximately 9 cubic yards of soil were excavated from Area E. In confirmation sampling, only two samples contained measurable TPH, and these at levels very near the detection limit;
- The soil sample collected from the pervious bottom of the catch basin contained no detectable volatile organic compounds; and
- Soil results from a soil boring installed east of the leach field indicated that soil had not been affected by VOC compounds.
